## Product Safety Notification: 3016547

Date: 03/31/2025

### Affected Product Part Numbers

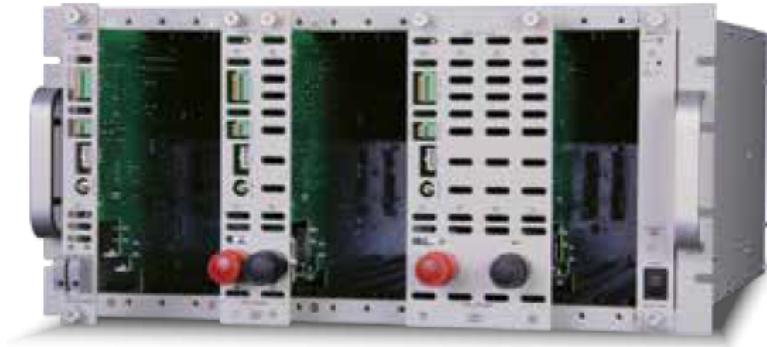
As a part of NHR’s integration into NI, we recently completed internal reviews of the architecture of the products listed above. NI determined, as a part of the review, that there is an intermittent failure associated with some of these units in which the chassis metal covers are not adequately electrically bonded back to the protective earth terminal.

*Model 4300 mainframe with 150, 300, & 600W loads*

The product is designed to have all accessible metal covers secured by screws, providing low resistance electrical bonding of the covers back to the main protective earth terminal. Due to the mounting points of the screws being insufficiently masked during painting, they may provide insufficient electrical continuity for grounding if paint is built up and the screws have high contact resistance to the covers. While the internal hazardous AC wiring is secured against loosening, in the case of a unit having insufficient grounding continuity, there is a risk of electric shock if internal AC wiring were to contact the metal surfaces. This could cause electric shock if a user touches the surfaces during this abnormal fault condition.

2. Qualified personnel may verify the grounding of your unit using a digital multimeter to check the continuity between all surfaces back to the main protective earth (PE) terminal on the rear cover or to the grounding blade of the AC inlet. Sufficient continuity is a resistance less than 100 milliohms, or less than a 4V drop during a 40A ground bond test between the covers and the PE terminal. Either test will show grounding continuity and confirm your unit does not exhibit insufficient grounding.

3. If you test your unit and discover that it does exhibit this failure or if you are unable to test it yourself, you should stop use of the product and return your unit(s) to NI where we will check for this failure and apply a fix free of charge if needed. Repairs will be warranted for ninety (90) days.
